*Queen Anne's Revenge*  
**Shipwreck Project**

**RESEARCH REPORT AND BULLETIN SERIES**  
**QAR-B-09-02**

**The Seat of Ease: Sanitary Facilities from**  
**Shipwreck 31CR314**  
*Queen Anne's Revenge Site*

August 2009

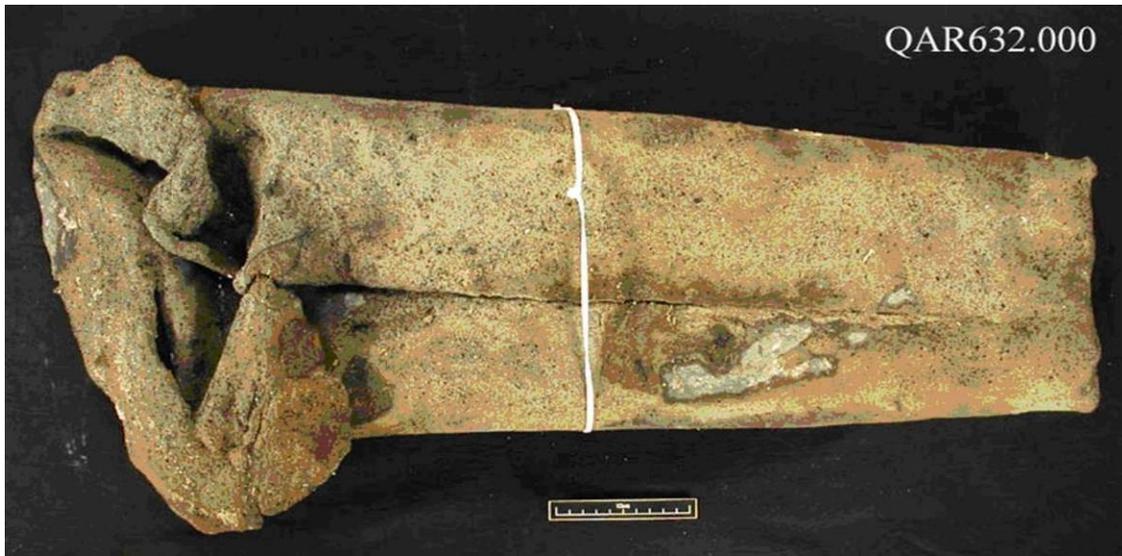
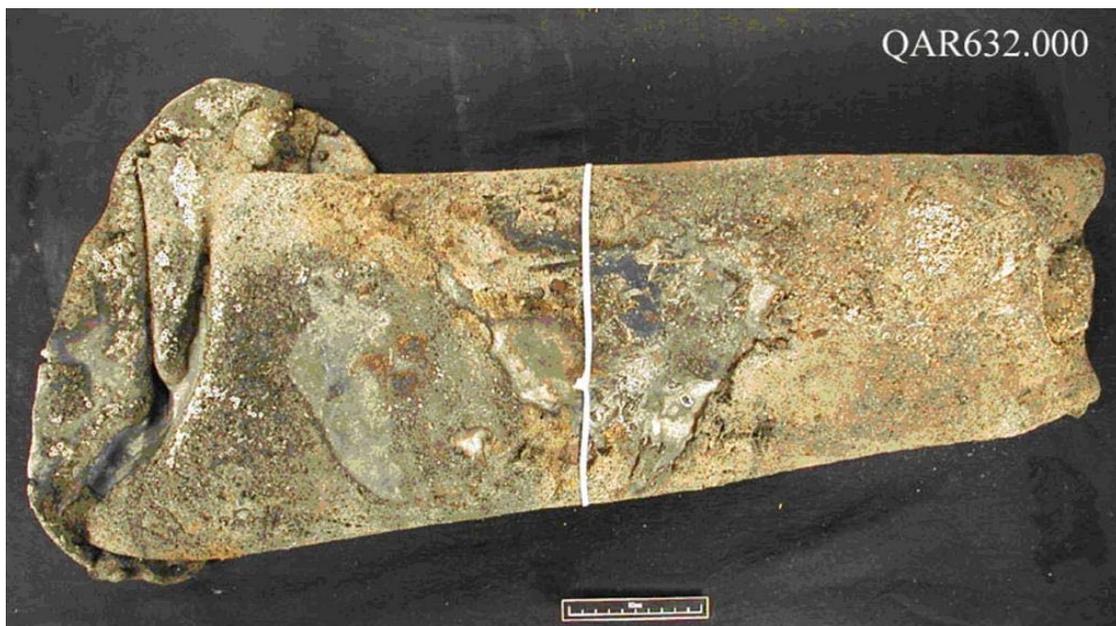
Figure 1: Seat of ease as recovered from shipwreck (QAR632.000)

On May 19, 2005, a flat tapered lead artifact (QAR632.000) was recovered from the stern area (Unit #07 E70 N20) of North Carolina Site 31CR314. This shipwreck is believed to be the pirate Blackbeard's flagship *Queen Anne's Revenge (QAR)* lost in 1718 at the entrance of Beaufort Inlet. This particular artifact has been identified as a "seat of ease" [Figure 1]. These devices were also known to many as a ship's "head" or "latrine, and were the sanitary facility aboard the ship.

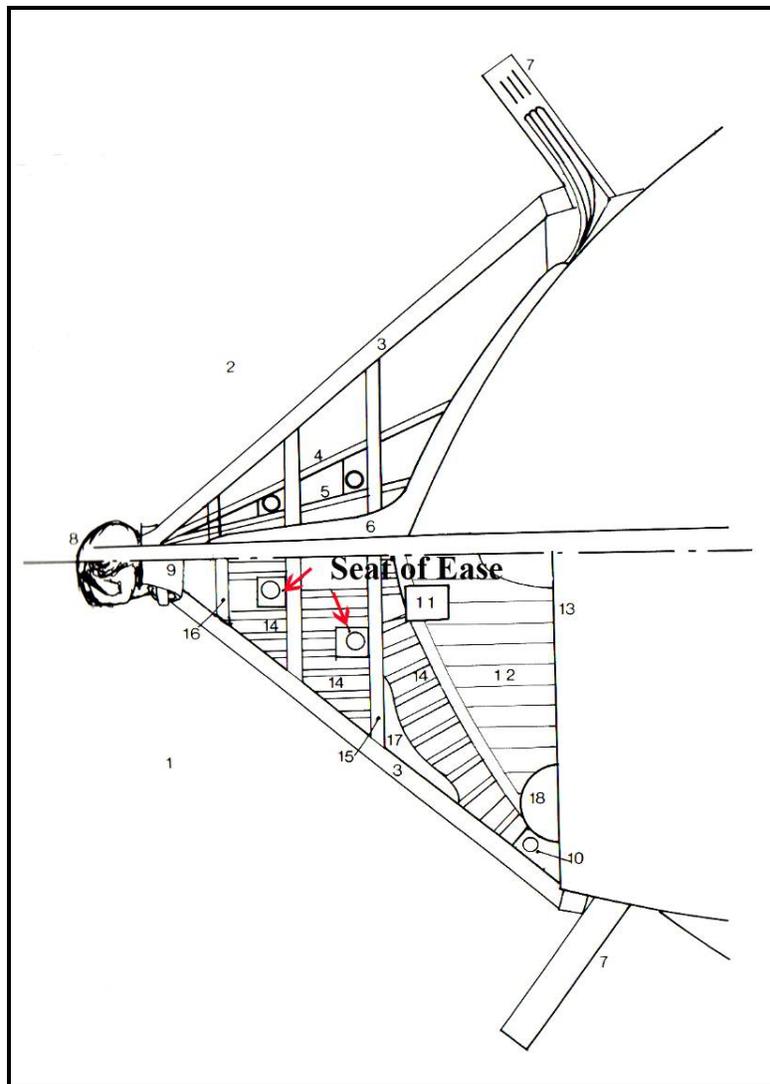
Figure 2: Drawing showing arrangement of seat of ease on bow of ship ca. 1760 (Lavery 1985)

Seats of ease began to be in common use aboard ships by the late seventeenth century (Simmons 1985:36). For the crewmen, these sanitary facilities were located on each side of the ships' bow and equipped with drainage pipes to direct excrement down to the sea. "The accommodations consisted of simple rectangular box(es) [with] a wooden fragment that seems to be a remnant of a "seat" that received the anatomy of the users" (Simmons 1985:37). The tapered lead tubing or soil pipe was attached to the wooden seat to guide discharge downward [Figures 2 and 3]. Surviving archaeological examples of the wood portions of seats of ease are from the 1628 Swedish warship *Vasa* and the *Bremen Cog* (1380) (Simmons 1985: 37-40; Dr. Frederick Hocker 2009: pers. comm.).

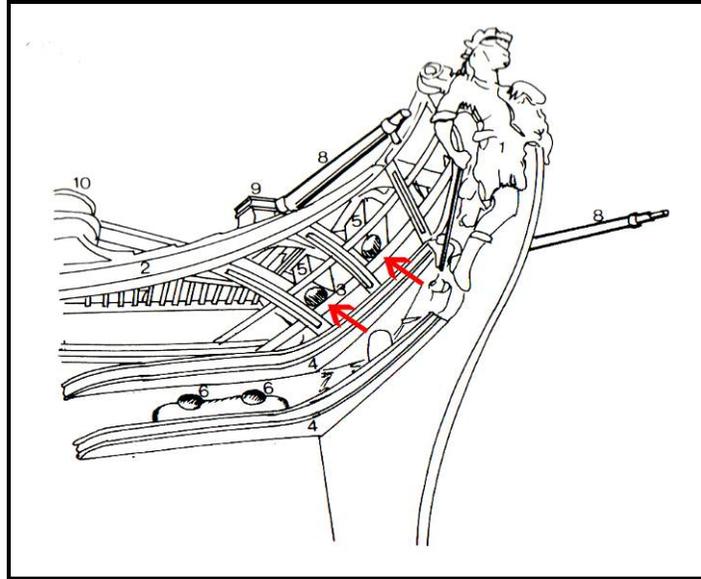
**Figure 3: Bow drawing with arrows representing discharge pipes from seat of ease ca. 1760 (Lavery 1985)**

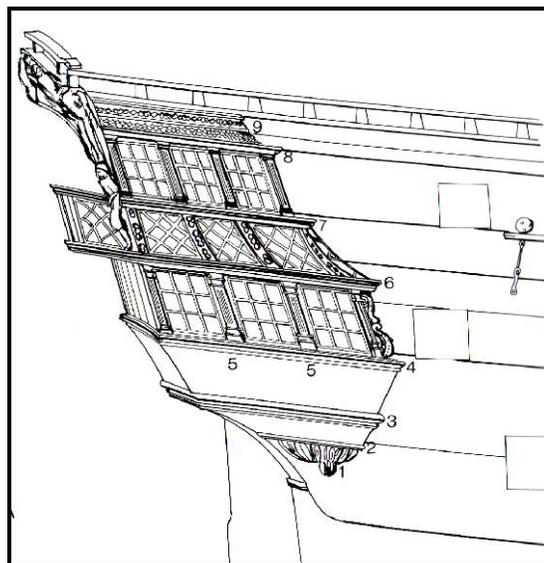
**Figure 4: Stern drawing with quarter galleries circa 1760 (Lavery 1985)**

For the captain and officers, these accommodations were located at the ship's stern area, known as the quarter galleries [Figure 4]. On a ship of war or large merchantman, these galleries or balconies projected from the stern area. (King 2000: 208). This arrangement was not much more sophisticated than the "heads" used by the crew, just a little more private. Many of these enclosed quarter galleries were arranged on two levels; each level had sanitary accommodations installed [Figure 5]. The upper galleries would have had lead drainage piping [Figure 6] leading to the external piping [Figure 6] leading to the external vents below while the lower galleries were fitted with a short length of lead drainage pipe leading directly down through the structure to the sea (Simmons 1985: 48).

The seat of ease was discovered at the very extreme edge of the wreckage suggesting that the QAR had quarter galleries along its stern, providing separate sanitary facilities for its officers. Quarter galleries were arranged either with one or two levels with sanitary accommodations on either level [see Figure 4]. The QAR seat of ease has a short length suggesting its location was on the lower level. These amenities were very basic in design with only a wooden seat with a round or oval opening and lead soil pipes carrying waste downward. Evidence of only one seat of ease has been revealed after full excavation of the stern area suggesting that a single sanitary facility was available for use at that location. Given the energetic inlet environment, however, it cannot be ruled out that lead lining from other extant seats of ease were naturally removed from the site during or after the wreck event. An outside chance is that the one found was located in the ship's bow for crew use and

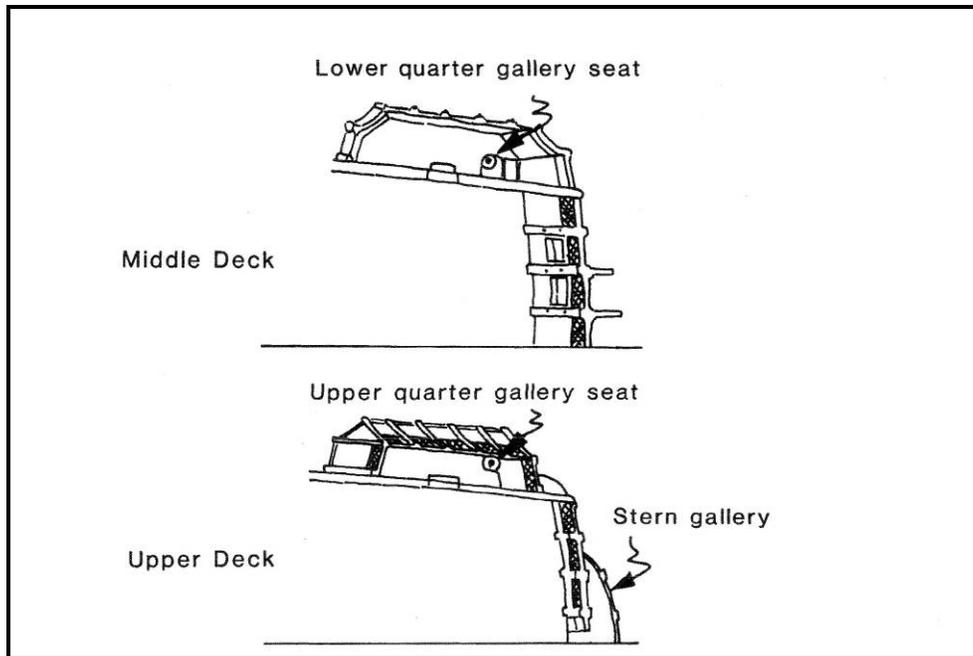
Figure 5: Two-level quarter galleries ca. 1670 (Simmons 1997)

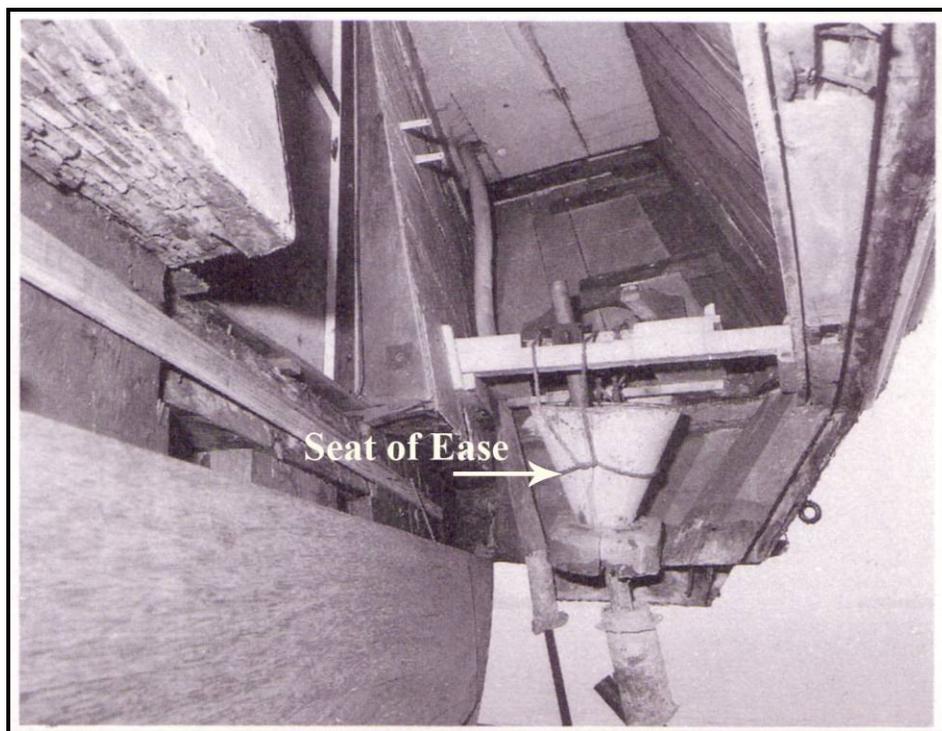
Figure 6: Seat of ease on the *Foudroyant* 1798 (Goodwin 1987)

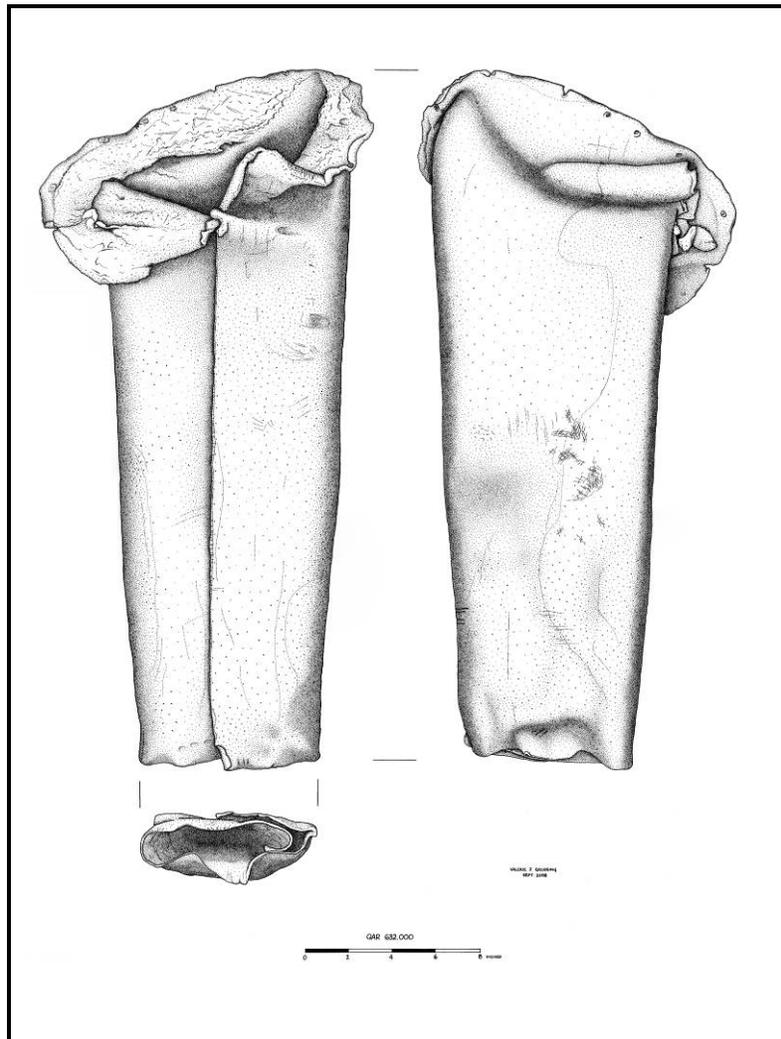
**Figure 7: Illustration of Seat of Ease (QAR632.000)**

The seat of ease recovered from *QAR* is composed of one thick semi-pliable piece of folded lead [Figure 7]. For detailed measurements and weight, see Tables 1, 2, and 3. The flanged top section contains multiple fastener holes along the top's rim for attachment to the wooden portion of the seat [Figure 8]. Only four complete fastener holes remain due to damage and corrosion. Also, the top has sustained deep gouges, which are likely post depositional damage. The top's opening and body would have been round or oval, but is now flattened due to damage occurring during or after the wreck event.

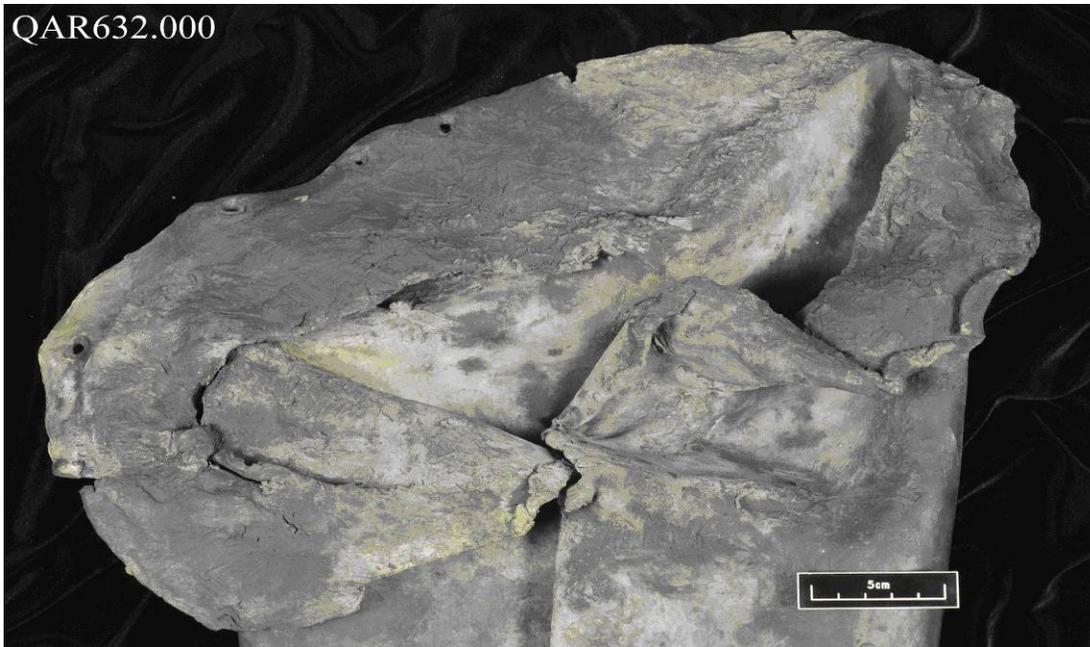
**Figure 8: Top flanged section**

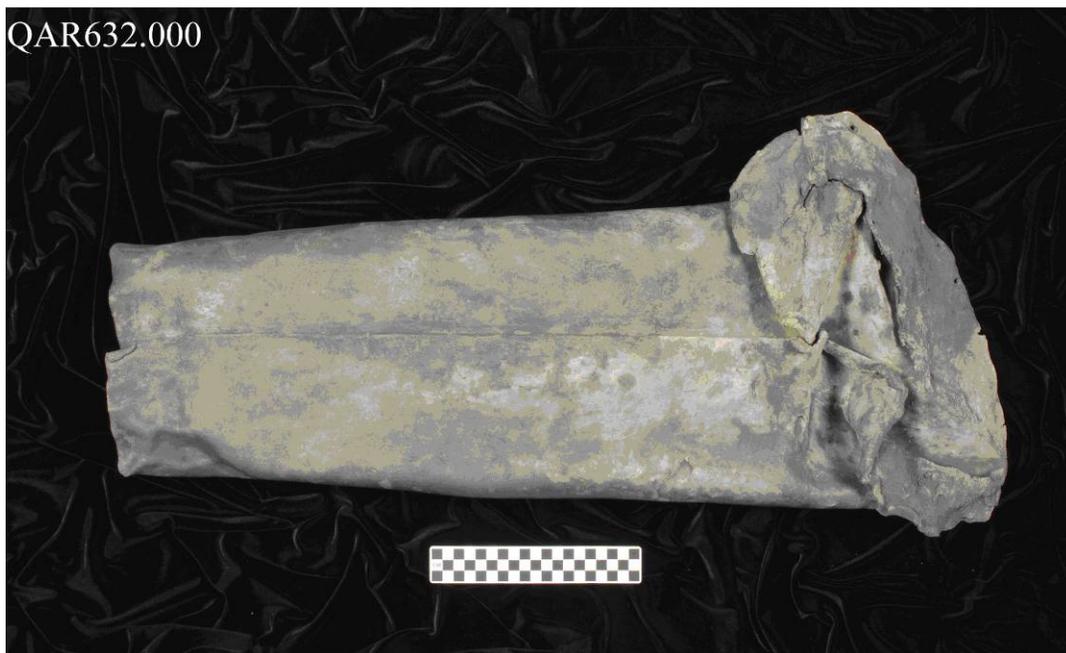
**Figure 9: Front section**

The body of the seat of ease is folded and tapered downward to the end facilitating discharge to the sea [Figure 9 and 10]. In the process of cleaning in the *QAR* conservation laboratory, wood fragments, a rope impression, and a textile impression were uncovered along one side of the body [Figure 11]. Molds were made of the textile and rope impression for further analysis.

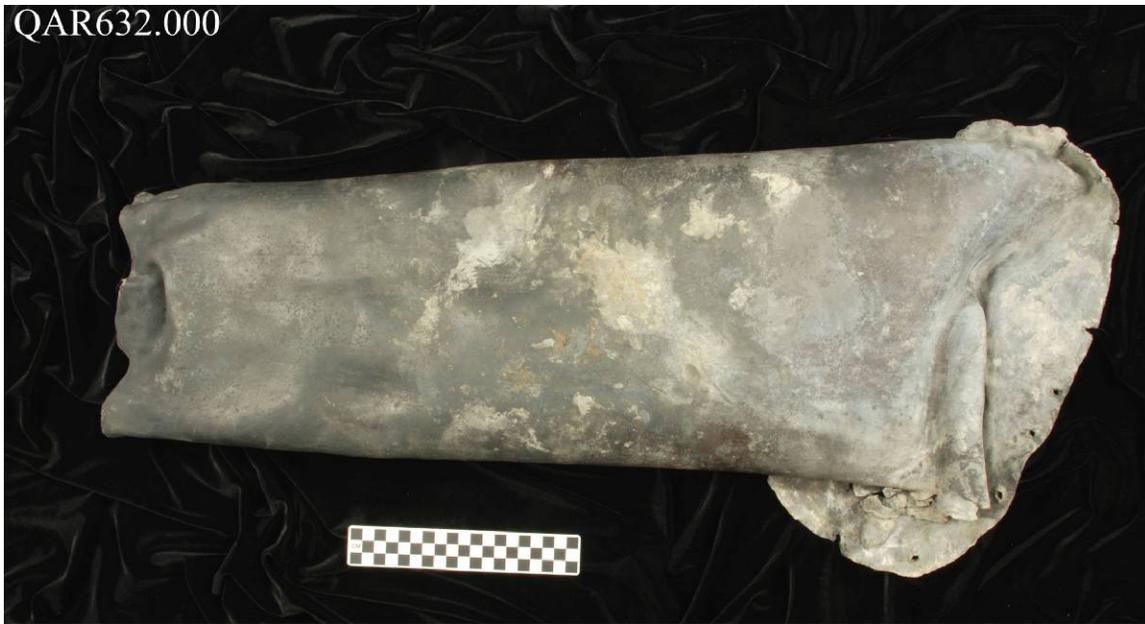
**Figure 10: Back section**

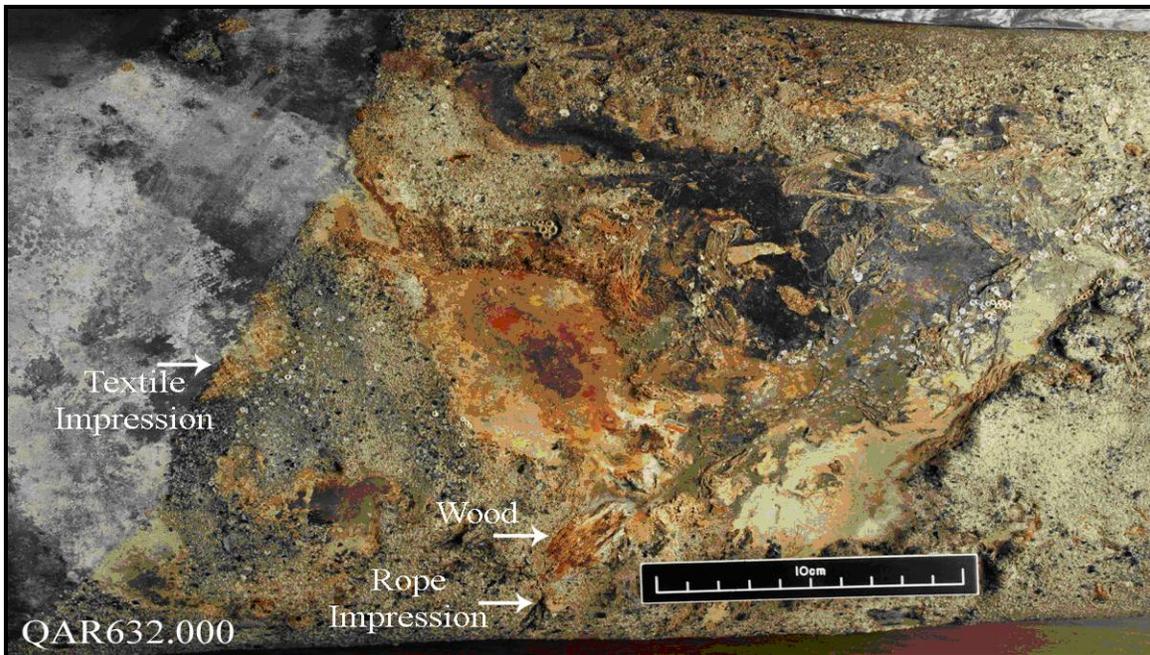
**Figure 11: Wood fragments, rope impression, and a textile impression on the seat of ease.**

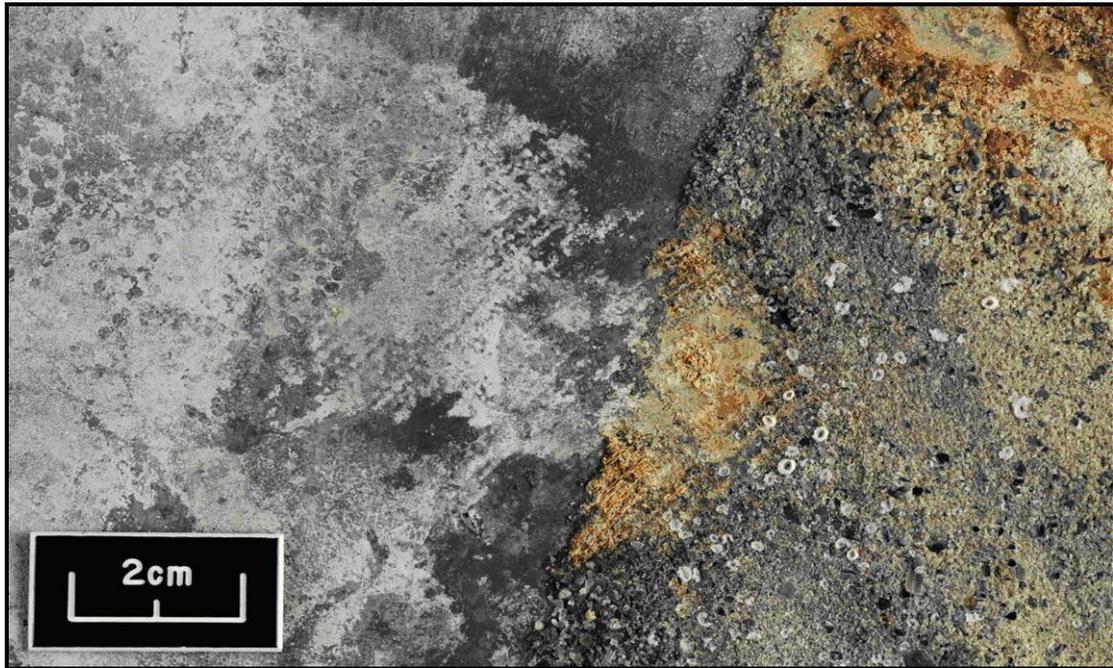
**Figure 12: Textile impression on seat of ease**

Adria Focht, an East Carolina University Anthropology graduate student, analyzed many of the textiles from the shipwreck as a directed study project, including the textile impression from the seat of ease [Figure 12]. With a thread count averaging 40 warps by 38 wefts per inch, Focht concluded that the textile impression was “a plain weave (one warp to one weft).” (Foch 2007: 27).

This particular textile was not sailcloth but another, less common type of textile associated with the shipwreck.

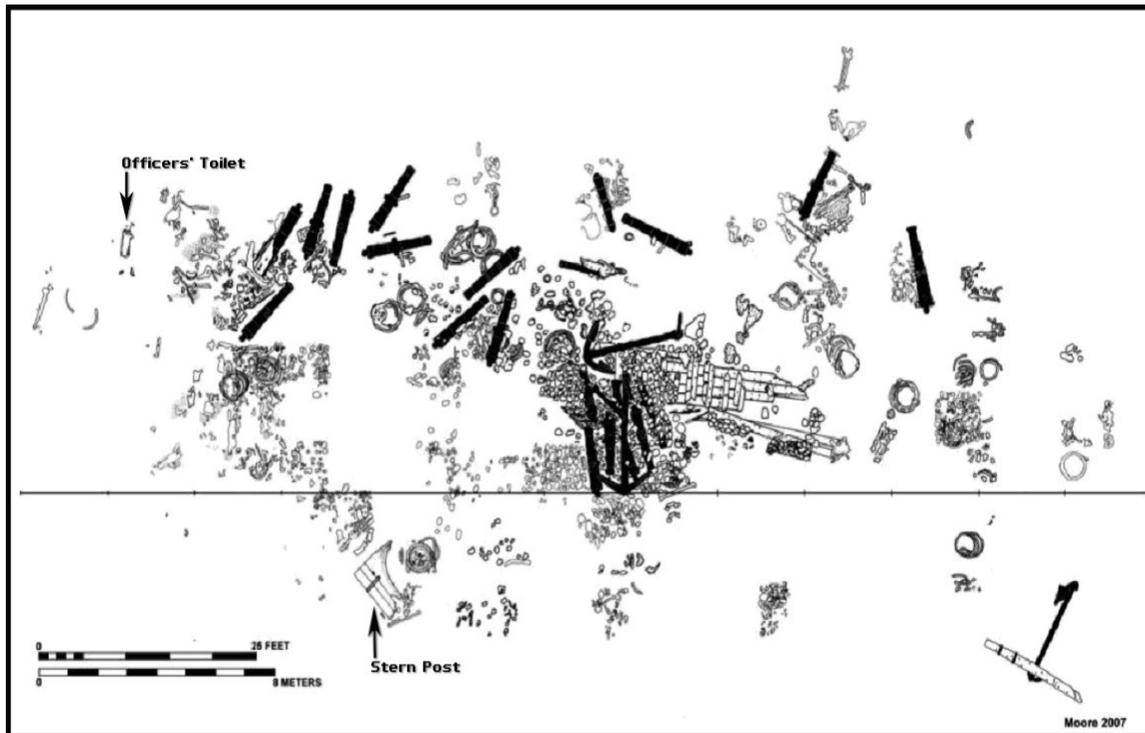
Figure 13: Distribution of material on the *Queen Anne's Revenge* site (Wilde-Ramsing 2009: 182 Figure VI-17)

The seat of ease was recovered in the stern area of the shipwreck (Unit #07 E70 N20). Within this unit were located one lead strip, two concretions, and the seat of ease. [Figure 13]
